# Our Water Mains Contaminate Us with E. Coli, Lead and Copper – Preventable Illness and Death Follow

**Robert Allan Leishear**

Robert Allan Leishear. Our Water Mains Contaminate Us with E. Coli, Lead and Copper – Preventable Illness and Death Follow. *American Journal of Water Science and Engineering*. Vol. 7, No. 2, 2021, pp. 72-96. doi: 10.11648/j.ajwse.20210702.15

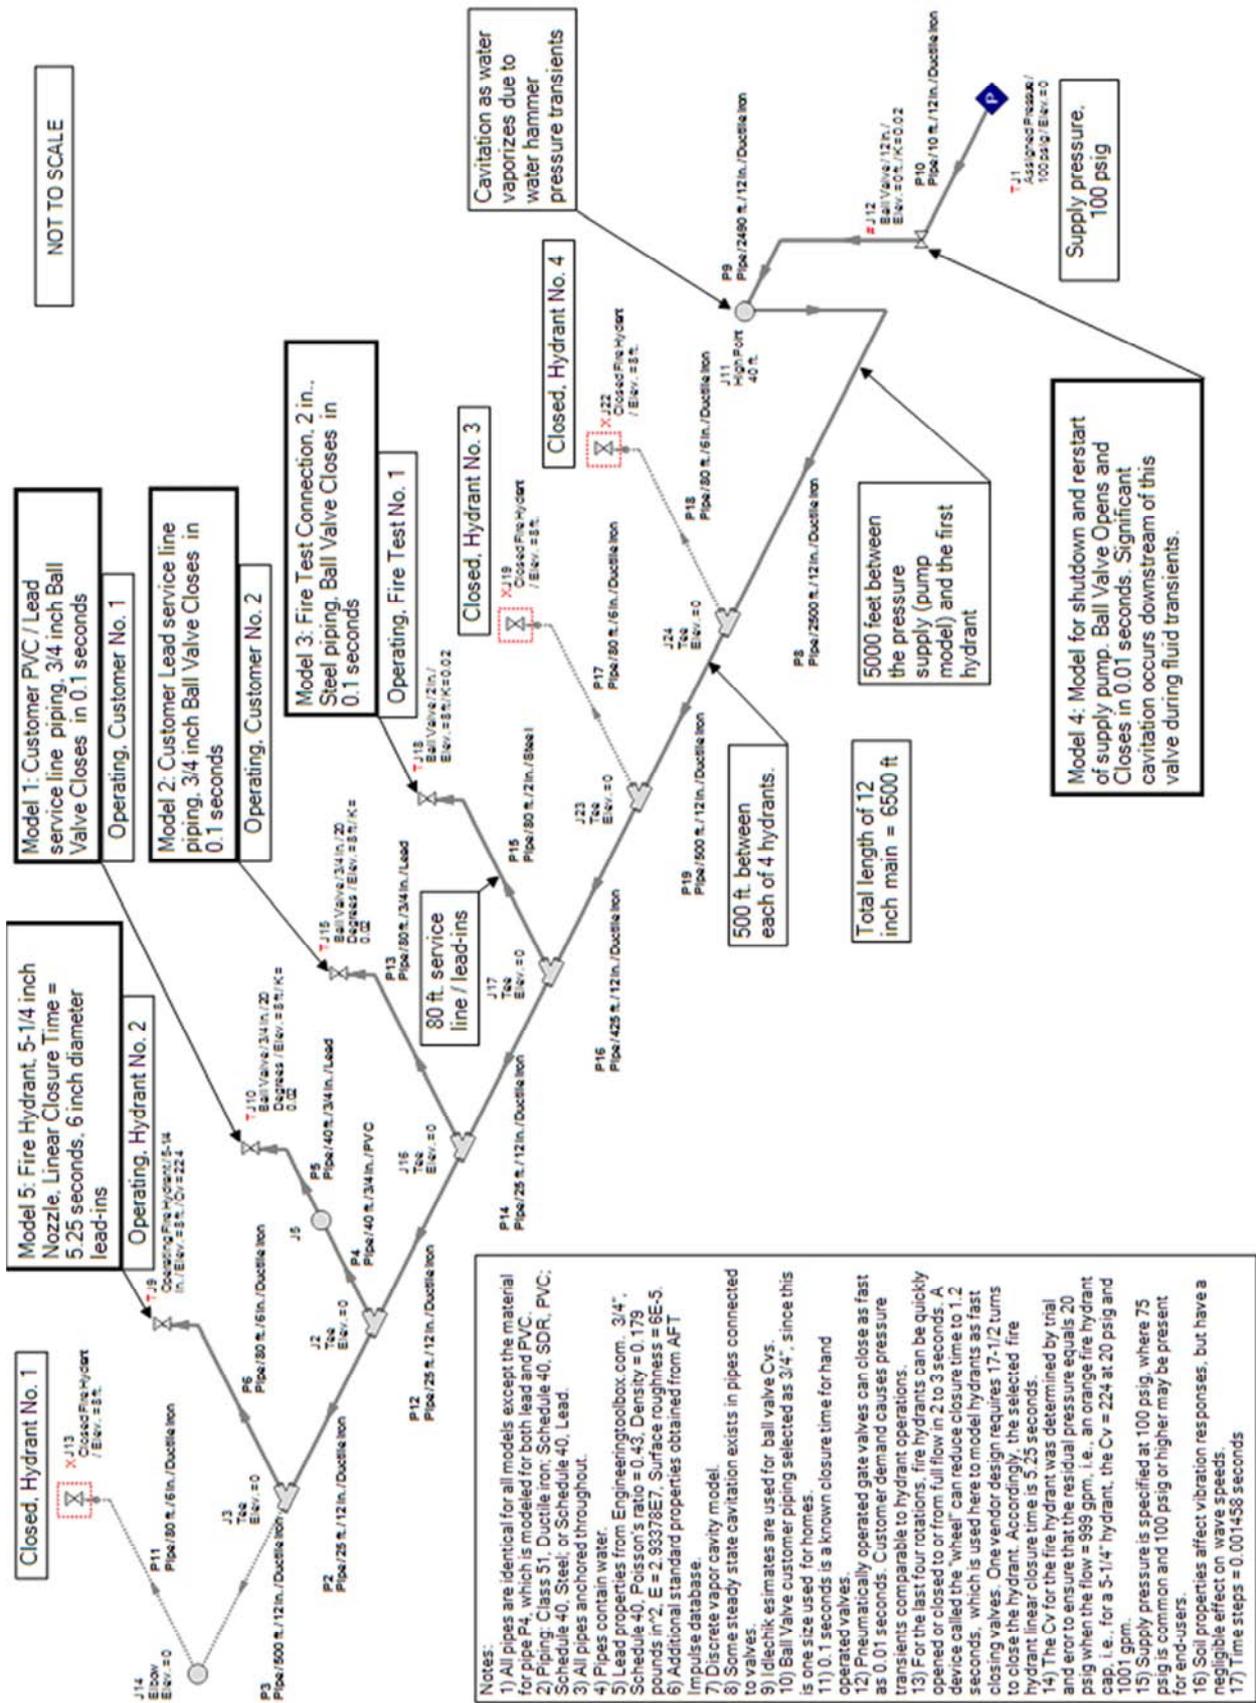
Figure 8. Water Hammer Models for Water Main Break Failure Analysis, Process and Instrumentation Diagram.

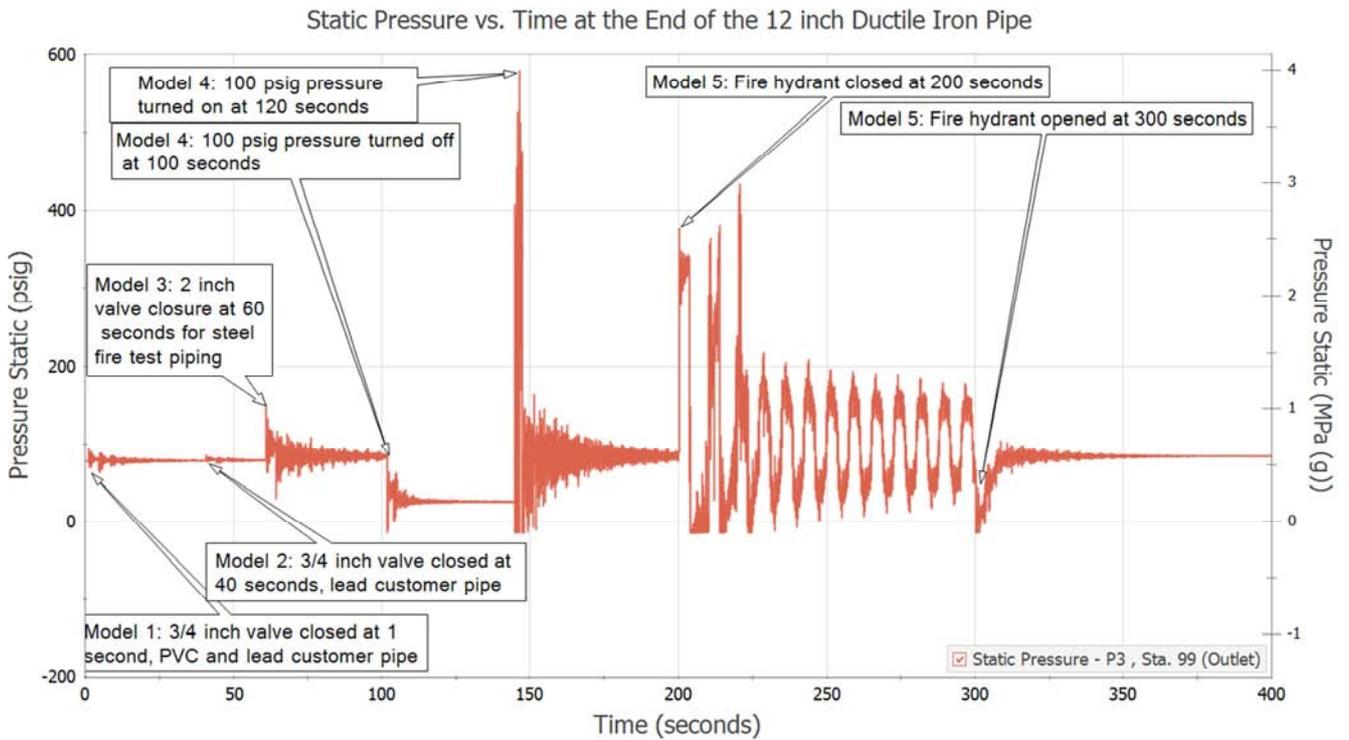
Figure 9. Transient Pressures at the End of the 12 Inch Main.

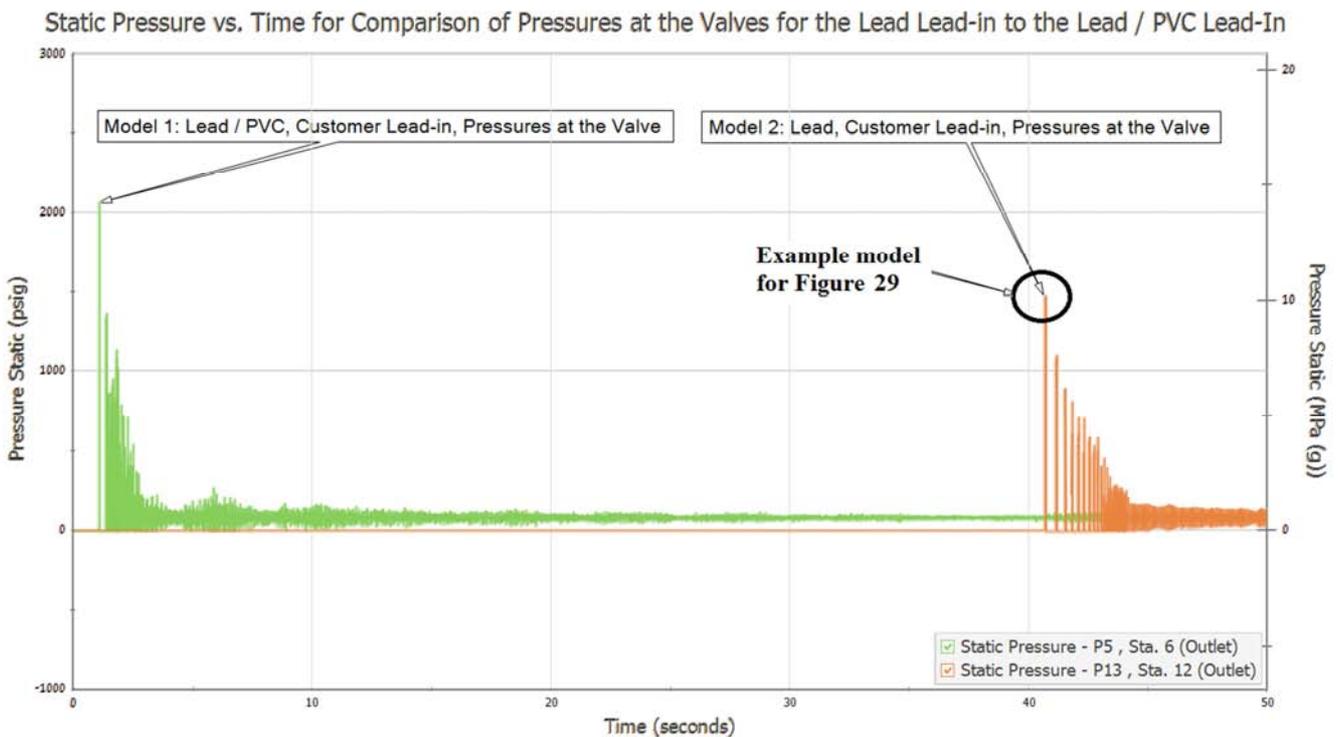
Figure 10. Comparison of Pressures for Lead vs. Lead / PVC Service Lines.

A second observation is that pressures are considerably higher in the piping connected to the valve, and this phenomenon is also due to wave reflections from the material interface. For the work considered here, earlier practices for replacing lead service lines was to replace only the city water supply piping and let the customer replace the lead pipes on their property. The fact was recognized that this practice contaminated customer drinking water. In fact the National Association of Corrosion Engineers lobbied congress to replace lead piping, and claimed that new construction damaged lead service lines. The fact is that attaching PVC piping, increased the lead service line stresses, and damaged the pipes to induce lead into customer drinking water.

In other words, what was considered to be a solution actually worsened the contamination problem. Current laws require that all lead piping should be replaced, and although this reflected wave problem will be inadvertently resolved, high piping pressures are expected to continue lead contamination. That is, water hammer pressures cause sufficient pressures to induce lead corrosion and water contamination, as evidenced by past customer contaminations.

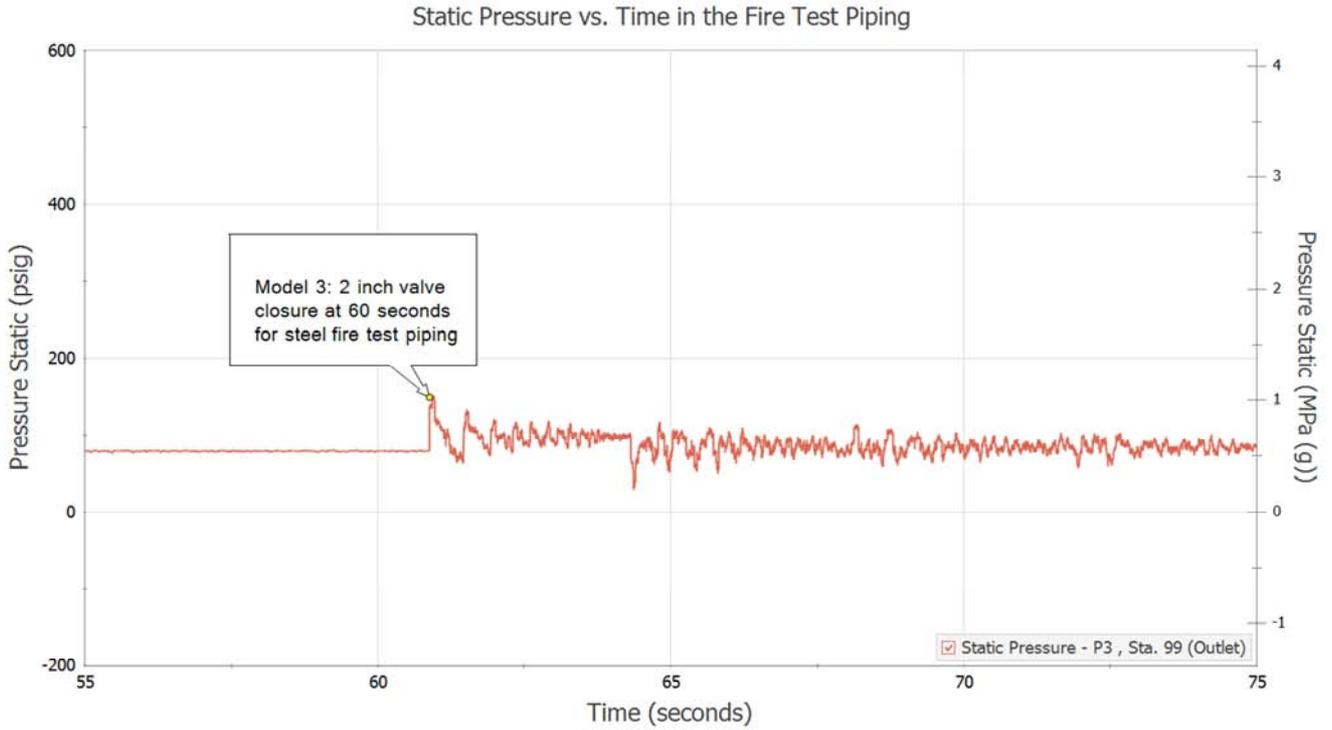
Figure 11. Inlet Pressures for Fire Test Piping.

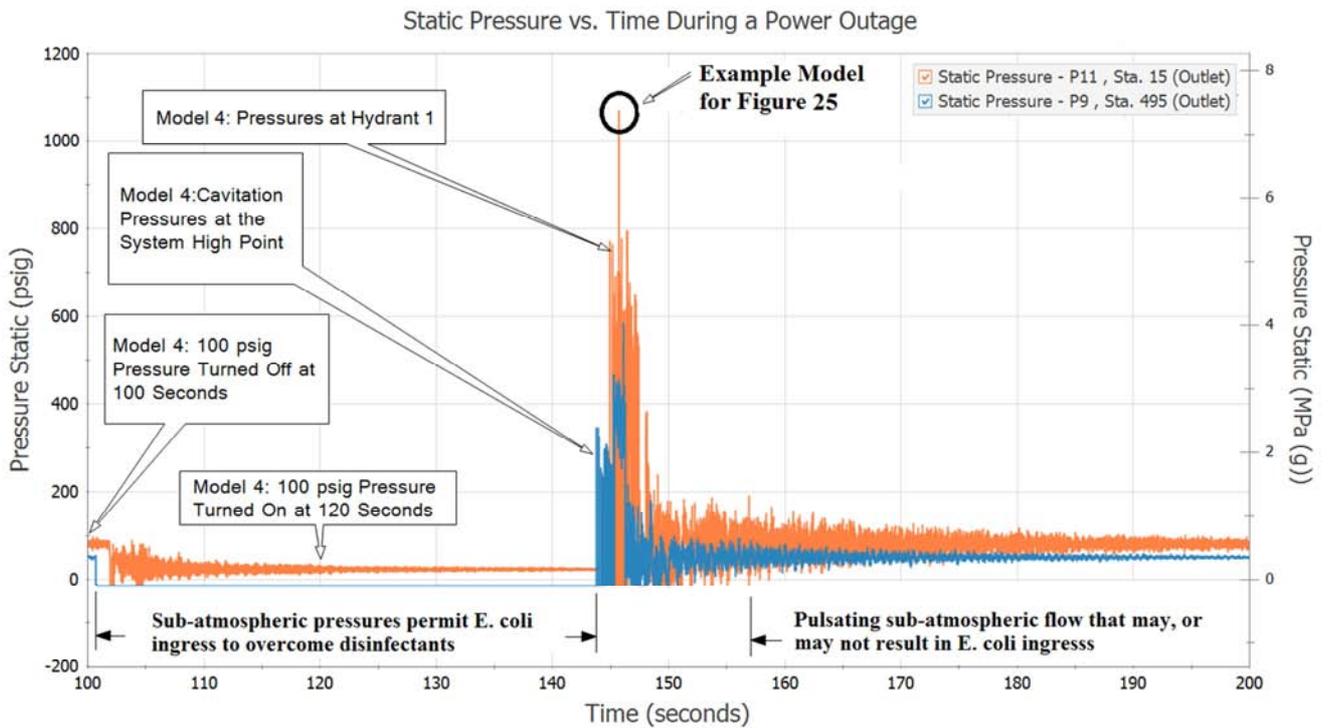
Figure 12. Maximum Pressures During a Power Loss.

Additionally, the opening of a valve in the modeled system to a depressurized section of piping, would cause pressures indicated in Figure 12. This situation can occur when traditional gate valves are replaced with butterfly valves to save costs, as witnessed on occasion by this author for actual systems.

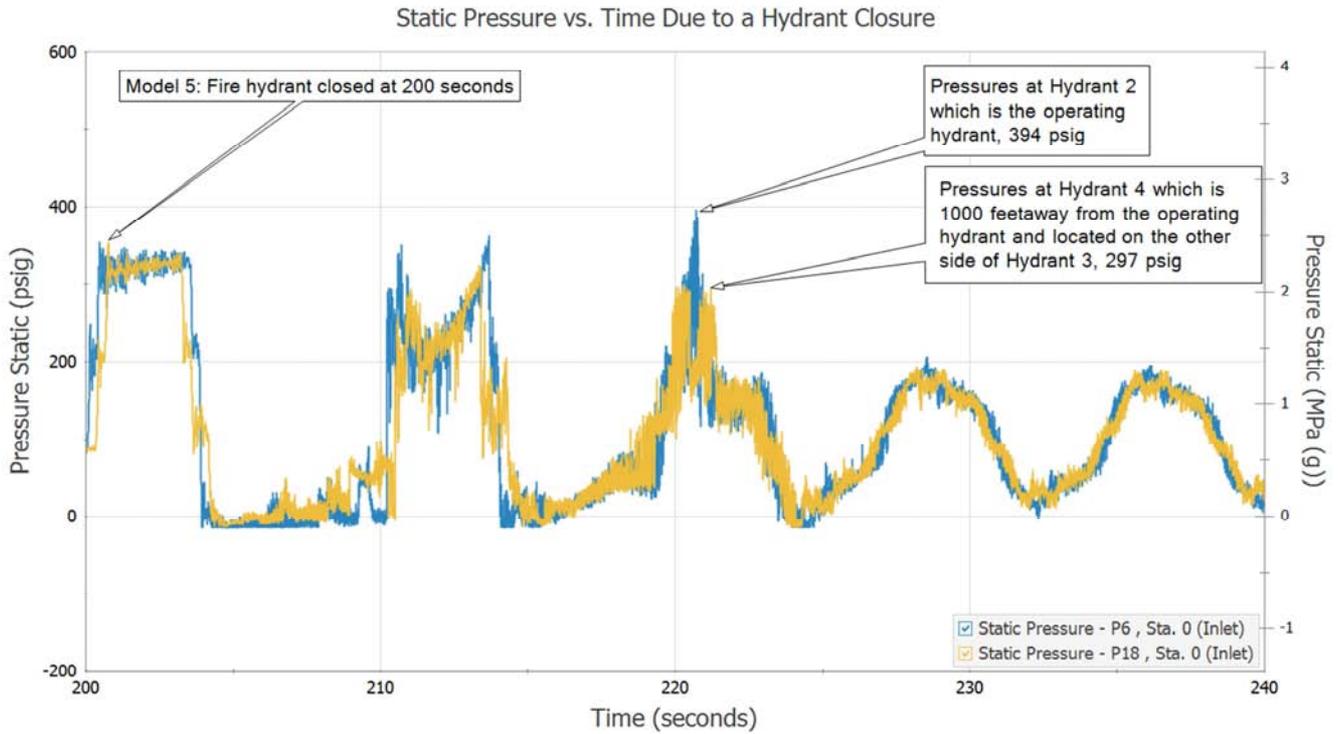
Figure 13. Pressures Due to a Hydrant Closure, Piping Inlets.

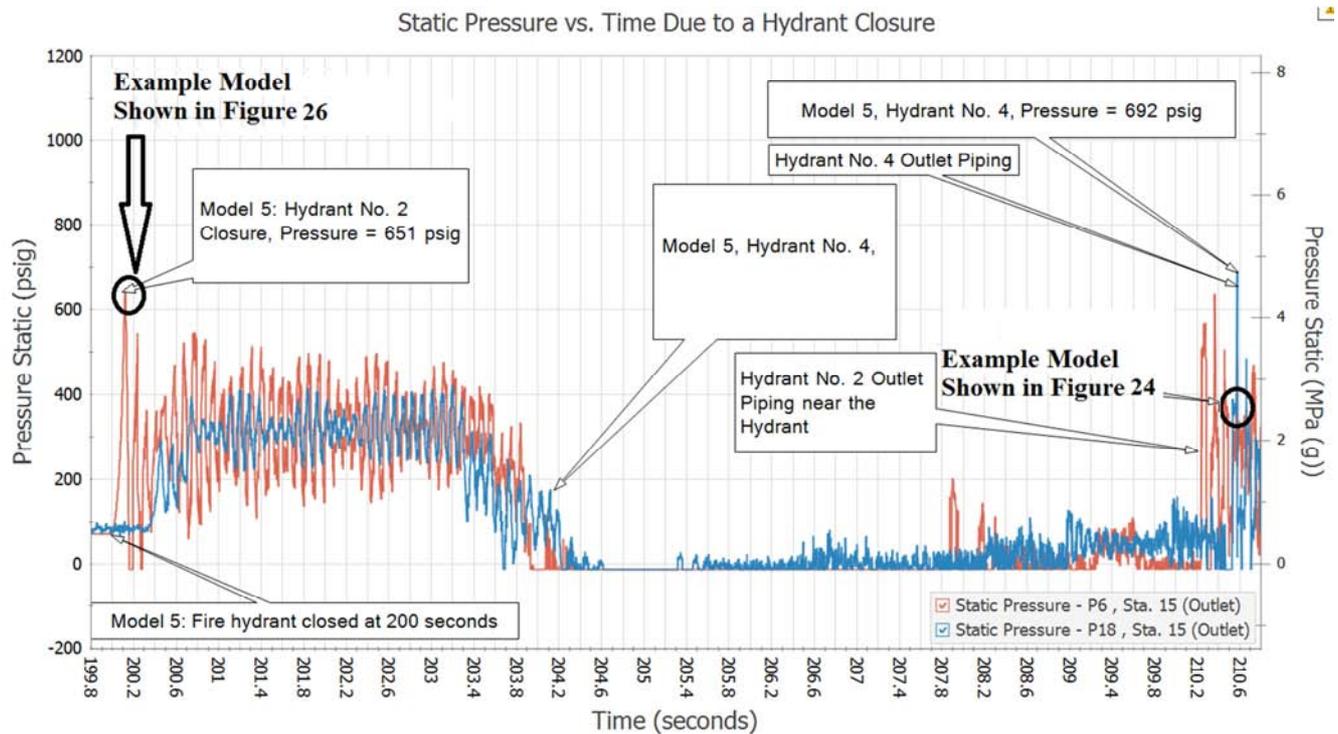
Figure 14. Pressures Due to a Hydrant Closure, Piping Outlets.

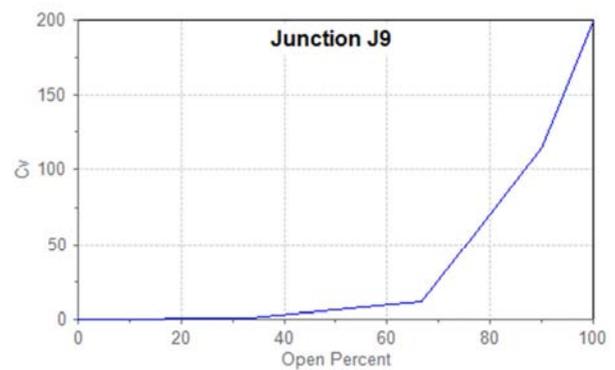
*Figure 15. Lower Limit of Cvs for Fire Hydrants.*

There are different hydrant manufacturers, different hydrants perform differently with respect to transient pressures, and hydrant performance data is not readily available. For this work a video of actual hydrant performance was used to establish the flow coefficient, or Cv, with respect to the opening percentage of the hydrant, where the Cv is related to the frictional resistance across a valve. To do so, a video of a flow test was carefully studied, where 17 1/2 turns were required to turn the nut on the top of the hydrant until it stopped. However, the pressure gauge attached to the hydrant showed that the maximum pressure was obtained during the first 4 rotations of the nut. Pressures were observed during rotations - and using the relationship that the pressure is proportional to the square of the flow rate - a ratio of pressures to flows was obtained, but a Cv was still required. A minimum Cv was obtained by trial and error for this system (Figure 14) by understanding that the delivery pressure must be at least 20 psig for a 1000 gpm delivered flow (See Table 1). The fact is that in-service flow rates for hydrants are likely higher at this pressure, but this flow provides a design pressure for this model, i.e., higher flows and higher Cvs will yield higher system pressures during transients. The hydrant Cv was varied using this model until the pressure and flow met this design requirement (Figure 15). Other requirements could have been specified as shown in Table 1.

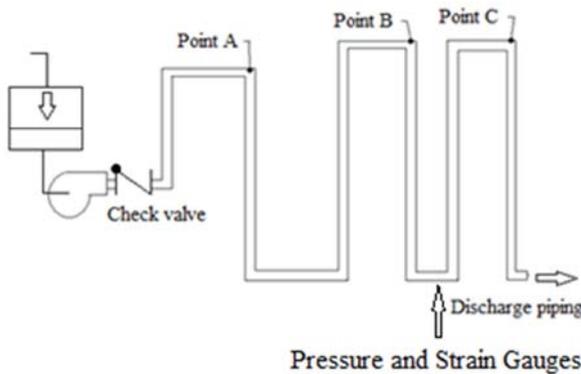
Figure 16. System Diagram for Water Hammer Tests.

The experimental basis for DLFs for hoop stresses was found by measuring water hammer pressures, measuring strains in the piping, and converting those strains to stresses using the modulus of elasticity for 3 inch nominal pipe size, Schedule 40 stainless steel pipe. The basic system layout for the 710 feet long piping system is shown in Figure 16. Measured pressures are shown in Figure 17, and Measured Strains are shown in Figure 18. The strain waves were in reasonable agreement with the closed form solution, and the maximum DLF was less than 4 for all measurements, where damping decreased the maximum DLFs, where the maximum DLF is multiplied by the calculated water hammer stress to determine a maximum failure stress.

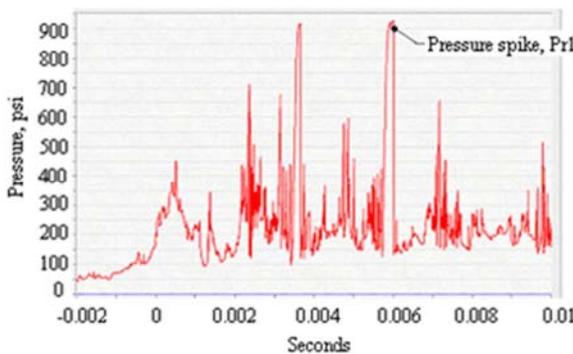
Figure 17. Pressure Measurement in a 21 psig System.

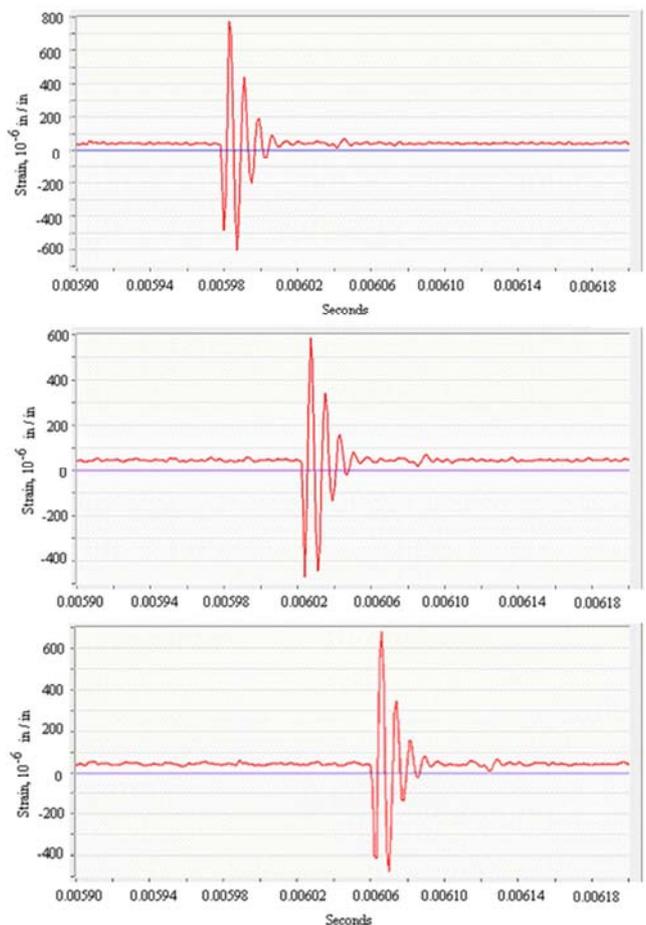
Figure 18. Strain Measurements (Pr1=piezoelectric pressure transducer) Depicting Pressure Wave Effects Due to a Water Hammer (Leishear [7]).

There have been two open questions for a long time with respect to this ongoing research. The first question still needs to be addressed, and can be stated as “What are the effects of pipe sizes on DLFs?”. This author’s opinion is that there is little effect, but proof is required and research to address this issue is planned. The second question is partially answered here, and can be stated as “Why do the strain wave magnitudes fluctuate along the pipe, as observed in Figure 18?”

process of fatigue corrosion is unique to the literature. Figures 22 and 23 show bands of corrosion that mimic the fluctuating stress patterns that are observed during the transmission of pressure waves in piping. These observations also fit the data collected in Figure 18.

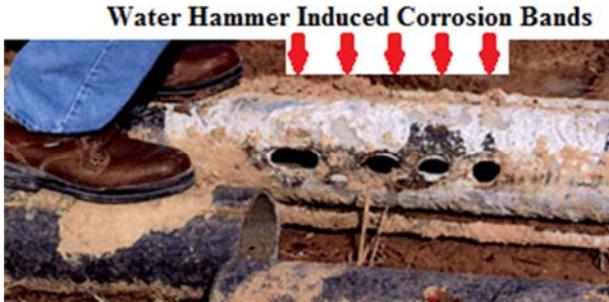
**Figure 19.** Evidence of Pressure Bands and Fatigue Induced Corrosion (Adapted from Leishear [3]).

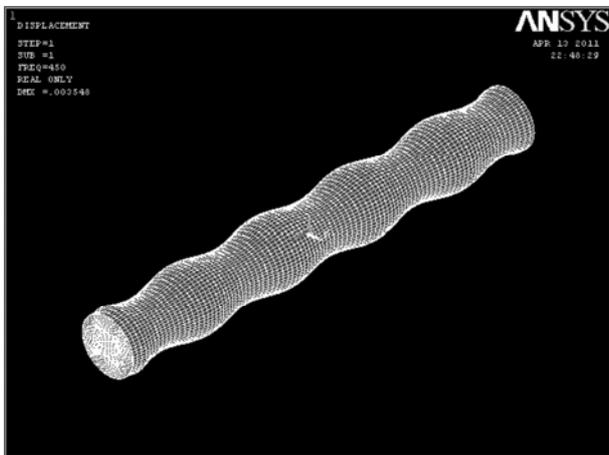
**Figure 20.** First Mode Vibration Frequencies in a Pipe (Adapted from Dweib [25]).

To begin to answer this question, note that pipes have multiple frequencies along their length, and that impact loads excite the first mode frequency of a pipe. Accordingly, any water hammer shock wave is expected to induce a fixed vibration in a pipe wall similar to the first mode vibrations along a pipe (Figure 20). Also, Beltman, et al. [26] performed research on explosive pressure waves in gas filled aluminum tubes. Permanent plastic deformations formed in the walls of the tubes, as shown in Figure 21.

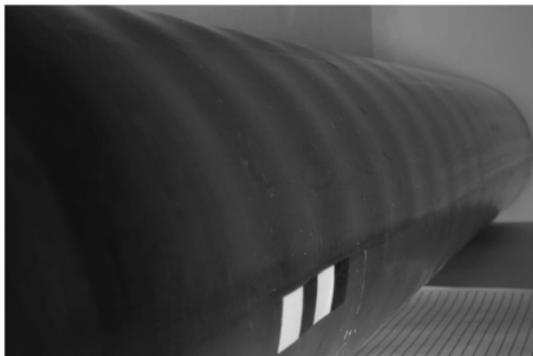
**Figure 21.** Experimental Demonstration of First Mode Frequencies (Beltman [26]).

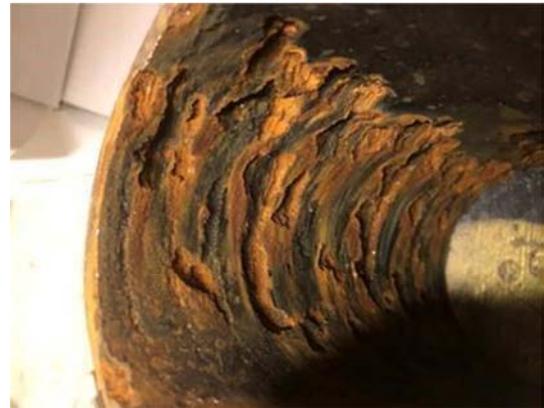
**Figure 22.** Bands of Fatigue Due to Water Hammer Pressure Waves.

The evidence is clear. Stresses, strains, and corrosion in pipe walls fluctuate due to water hammer waves.

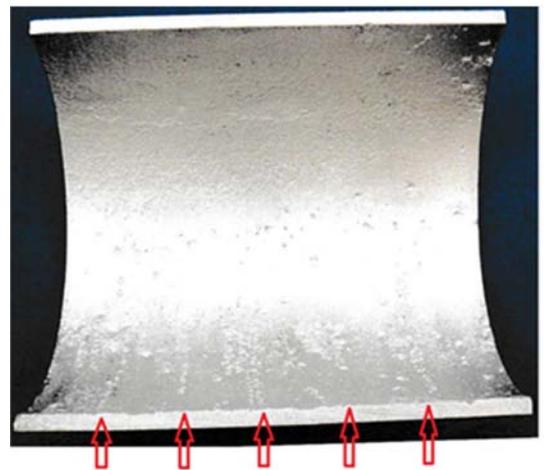
**Figure 23.** Incipient Bands of Fatigue Due to Water Hammer Pressure Waves – Surface Cleaned For Corrosion Evaluation.

subjected to cyclic fatigue from pressure waves will have many high stress locations. Specifically considering Figure 23 for a 6 inch nominal pipe size Schedule 40, ductile iron pipe, the distance between corrosion bands equals the period of vibration for the pipe wall, which in turns equals the distance between high stresses due to water hammer. The striking conclusion is that for a mile of pipe, there are 5280 feet · 12 bands per foot=63360 potential failure locations.

In other words, for one mile of 6 inch steel water mains, there are 63360 locations that are each equivalent to a fatigue test failure. This new insight can be applied to piping fatigue failures as well as corrosion. Since each of these failures is an independent event, and fatigue is a statistically random process, the number of cycles to failure is additive when predicting the probability of fatigue failures. If there is one failure in 100,000 cycles, then there are two failures in 200,000 cycles for different locations, and so on. This information can be used to better understand the immense scope of water main breaks.

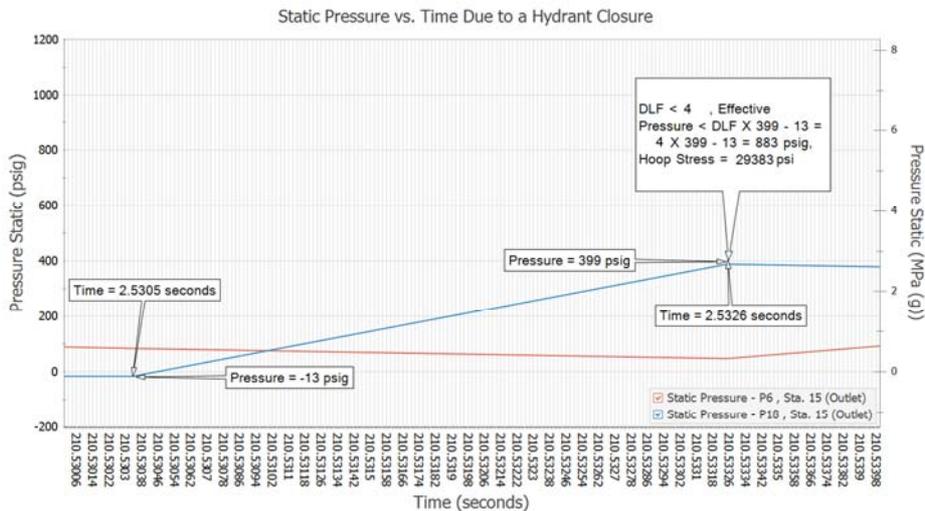
Figure 24. DLF Considerations for One of the Many Pressure Surges Due to a Hydrant Closure, As Shown in Figure 14.

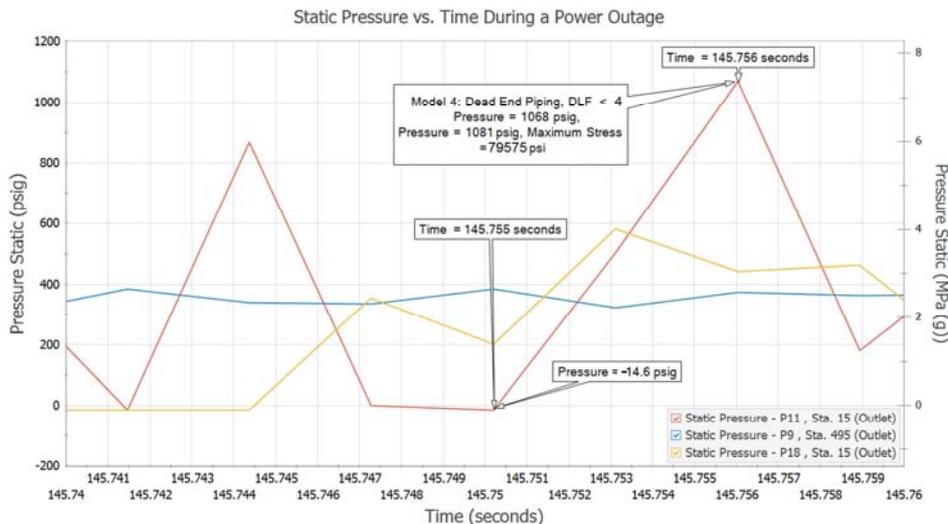
Figure 25. DLF Considerations for One of the Many Pressure Surges Due to a Power Outage, As Shown in Figure 12.

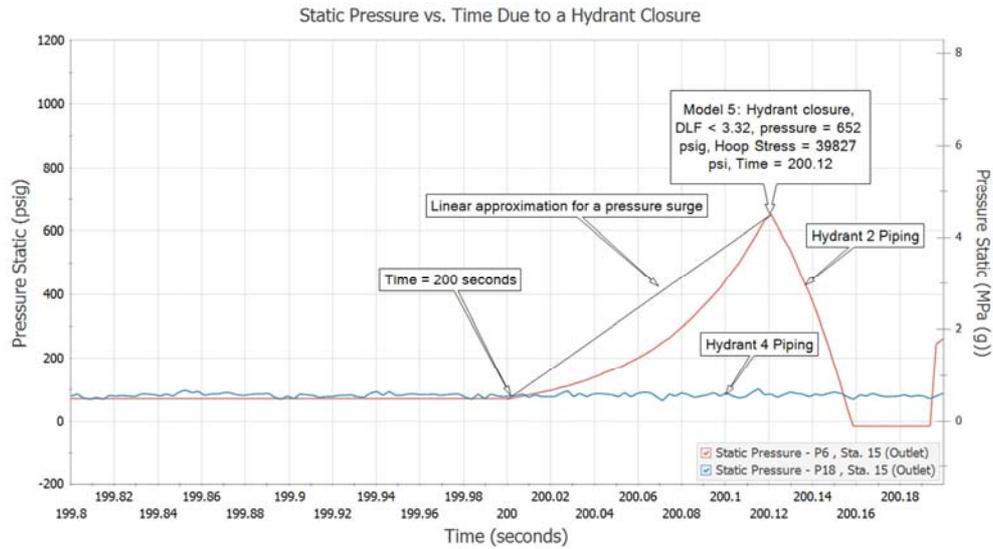
Figure 26. DLF Considerations for One of the Many Pressure Surges Due to a Hydrant Closure, As Shown in Figure 14.

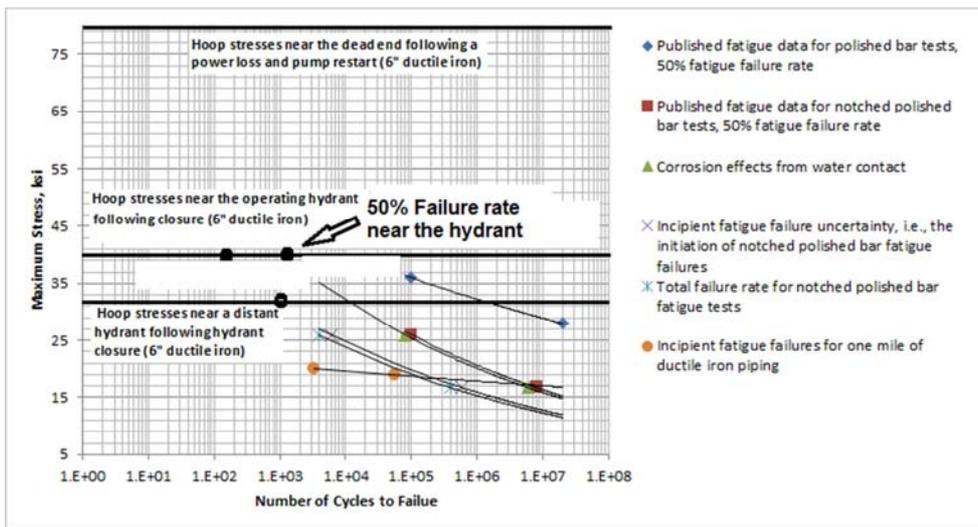
Figure 27. Ductile Iron Piping Fatigue Evaluation.

2. The next highest stress occurs near Fire Hydrant 2 when it closes, and is about half of the stress caused by a power outage (Equation 10, 39827 psi). Initial failures can occur in as few as 10 cycles, and about half of the pipes are expected to crack in 1000 cycles if there is significant scratching of the surface. Damages are predicted for a DLF < 3.24 or DLF < 2.00.

3. The lowest stresses that were specifically evaluated were for Fire Hydrant 4, which is located away from the closing hydrant (Equation 6, 29363 psi). Note that failures are not expected until about 1000 cycles, unless multiple failure locations are considered. In this case, initial failures can occur at any time. Damages are predicted for a DLF < 4 but fatigue cracks are not expected DLF < 2.25, where these fatigue stresses will contribute to cumulative damage when this Hydrant 4 hydrant is closed. Also, “fatigue corrosion” may be an issue at these lower stresses, where this new theory needs further research.

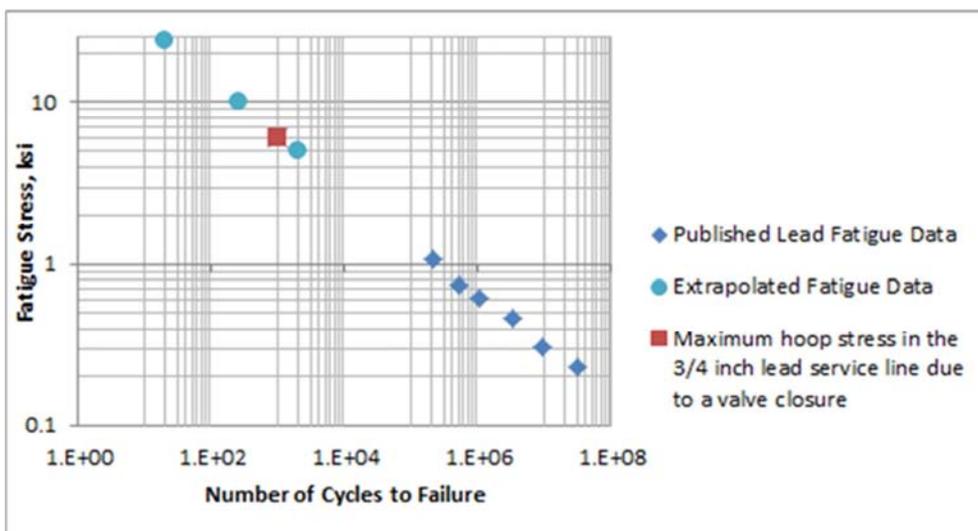
Figure 28. Lead Piping Fatigue Evaluation.

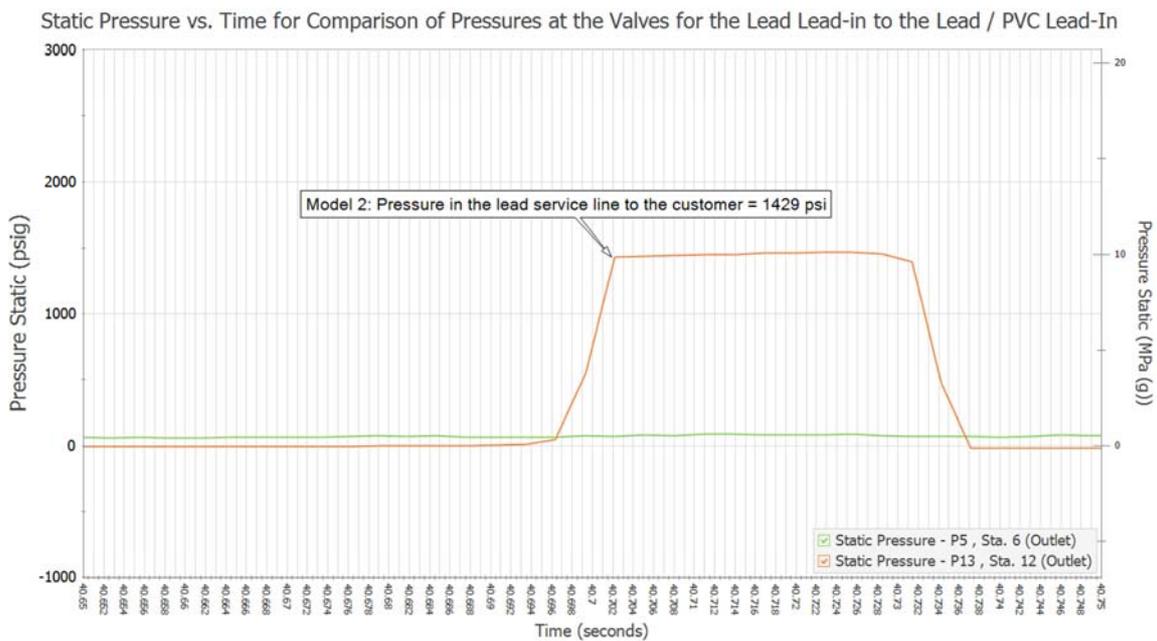
Figure 29. Lead Service Piping Fatigue Evaluation, As Shown In Figure 10.
